# Blade leading edge erosion: damage limitation, containment and prevention

During recent tests conducted by WTG Offshore using ORE Catapult’s rain erosion test rig facility in Blyth, some important discoveries came to light:

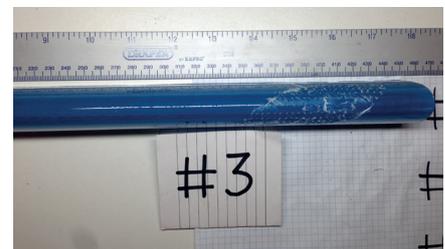
| Tricoat 1 | Two hours medium erosion damage. |

Tri Coat 1 Two hours Photo 1

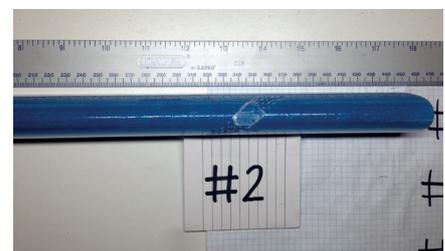
| Tricoat 2 | One hour light erosion damage. |

Tri coat 2 first test failure 1hr photo 2

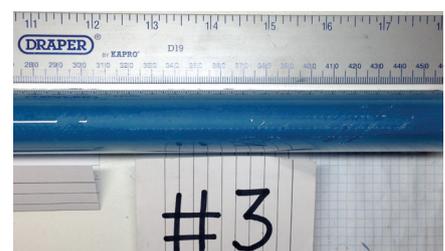
| Tricoat 3 | Four and a quarter hours very light erosion damage. |

Tri coat 3 Four hours Photo 3

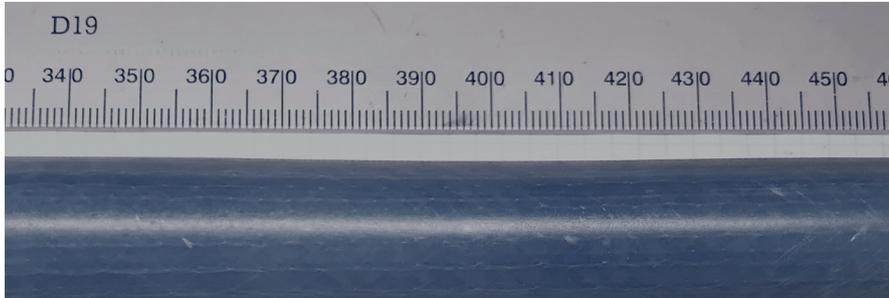
Coating applied over erosion damage (Prefailure 3hrs)

The milk white spots at 357/412cm indicate areas of delamination starting. These areas look to have started above the stitch line of the biax fabric

Where areas of erosion have removed part of the substrate resin and possibly broken some glass stands, even though minimal and not through the outer layer of the fibreglass, failures will occur at these resin poor exposed/broken fibre glass areas.

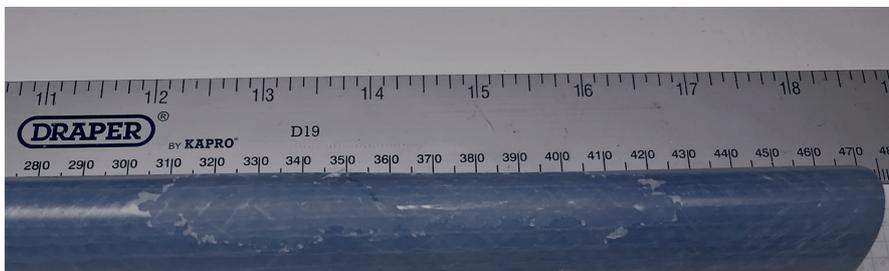
Coating Failure (3.25hrs)

Once these areas of delamination occur, failure of the coatings is rapid and aggressive in nature.
