IV tester integrated electroluminescence imaging in industrial Si solar cell production

Words: Dr. K. Ramspeck, Dr. S. Fischer, S. Schenk, S. Zimmermann, Dr. M. Alt
h.a.l.m. elektronik GmbH

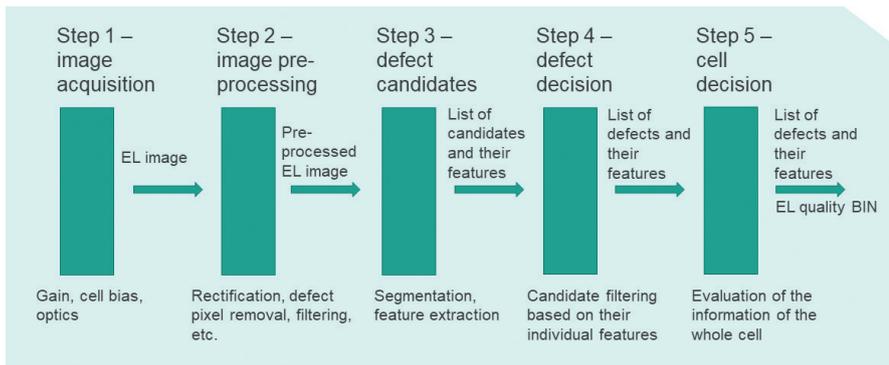
Figure 1: Scheme of a typical EL evaluation process flow, showing the different steps in the process of obtaining statistics on individual defects and defining a quality BIN for a solar cell from an EL image.

Its main applications in solar cell production are quality sorting and identification of processes that cause defects. For quality sorting, cells containing different defects exceeding a certain severity shall be sorted into lower quality bins. For the detection of deficient production steps, statistics on different defect categories are required. To obtain the relevant numbers, typically an EL evaluation pipeline is implemented (figure 1). In the first step, the image is recorded using optimised hardware settings including gain, image acquisition time and bias applied to the cell under evaluation. Step 2 comprises image pre-processing such as rectification, defect pixel removal or filtering. In step 3, segmentation of the pre-processed image and feature extraction provide a list of defect candidates and their features. Filtering of defect candidates based on their features provides the defects of interest in step 4. Finally, the last step comprises an evaluation of the EL information of the whole cell under test in order to assign a BIN class. Please note that the image analysis techniques employed for the different steps might differ between implementations.

PVControl-EL-eval 2.0 incorporates two concepts that can be combined or applied separately for solar cell quality and process control. Individual defects of different classes are extracted, visualised in an overlay image and their features such as count, area and severity are measured and stored. Application of thresholds to these features provides a basic sorting of cells into quality bins. However, the requirements for solar cell sorting are typically more complex and they are individual for each factory or at least for each company. Furthermore, they evolve as the production process changes. For this purpose, h.a.l.m. offers a cell sorting configuration that is specific to each customer.

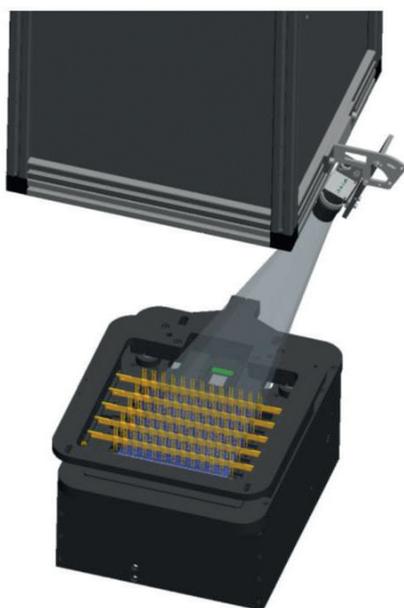
Figure 2: Setup of the h.a.l.m. IV tester with integrated EL system. The electroluminescence camera is mounted at the flash box of the IV measurement system and the software displays IV and EL results together.

As a leading manufacturer of *IV* measurement equipment, h.a.l.m. elektronik GmbH has integrated the EL imaging system with the *IV* tester into one end-of-line characterisation platform (figure 2). The EL camera is mounted at the flash box, and the

EL image is acquired in one measurement sequence together with the IV curves. The system is equipped with automatic defect detection algorithms in the image analysis software package PVControl-EL-eval 2.0 ready for usage with all common cell types.

Acquiring IV data and an EL image without re-contacting the solar cell saves floor-space, contacting equipment and (most importantly) reduces breakage rates. Furthermore, the results from EL imaging and IV testing are collected in one database. This enables combined analysis approaches of EL and IV results and statistical data analysis to correlate EL defects and their severity with IV data anomalies. We expect such integrative data correlation approaches to become more common in the PV industry in future, particularly in the context of

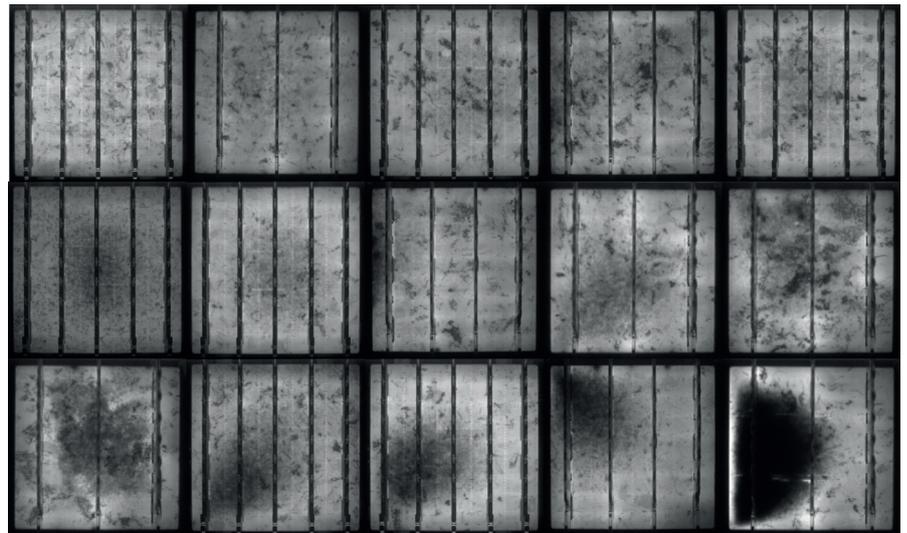
Figure 3: EL images showing cells with contact formation defect with increasing severity level. At the top, the defect is almost not visible, while the last cell at the bottom shows a clear, large, almost black region.

The ability to measure any kind of defect makes EL a mighty tool, but leads to challenges in rigorously defining quality criteria and discriminating the different root causes of visible defects. The main challenge is an unambiguous formulation of the requirements for the different quality grades, including definitions for all occurring defects in all their representations. Since most defects occur with different severities as shown for one example in figure 3, the line between different quality grades is intrinsically difficult to define.

A close cooperation of EL system supplier and solar cell manufacturer is therefore required, as the quality BIN definition typically cannot be described in a clear written specification. For determining the BIN definition, it is particularly difficult to set the cell grade for cells with defects of intermediate severity. According to our experience, the decision for such cells is so difficult that it depends on the person taking it or even varies if the same person assesses the same cell twice. The most reliable way to achieve a well-defined boundary between the different quality grades is sorting a batch of representative images by at least three trained employees of the solar cell manufacturer. The batch has to contain a sufficient number of images of cells with all defects that occur in the factory as well as images of cells without defects. Combining the rating from three experts consolidates clear assignments to quality bins and demonstrates in which cases it is not
