# Failure is not an option

by Morgan Troedsson, Product Manager, FORCE Technology

The long-term efficiency of wind power relies on periodic revisions, with recurring inspection and maintenance. Morgan Troedsson, Product Manager at FORCE Technology, talks about what they bring to this vital subject on system reliability.

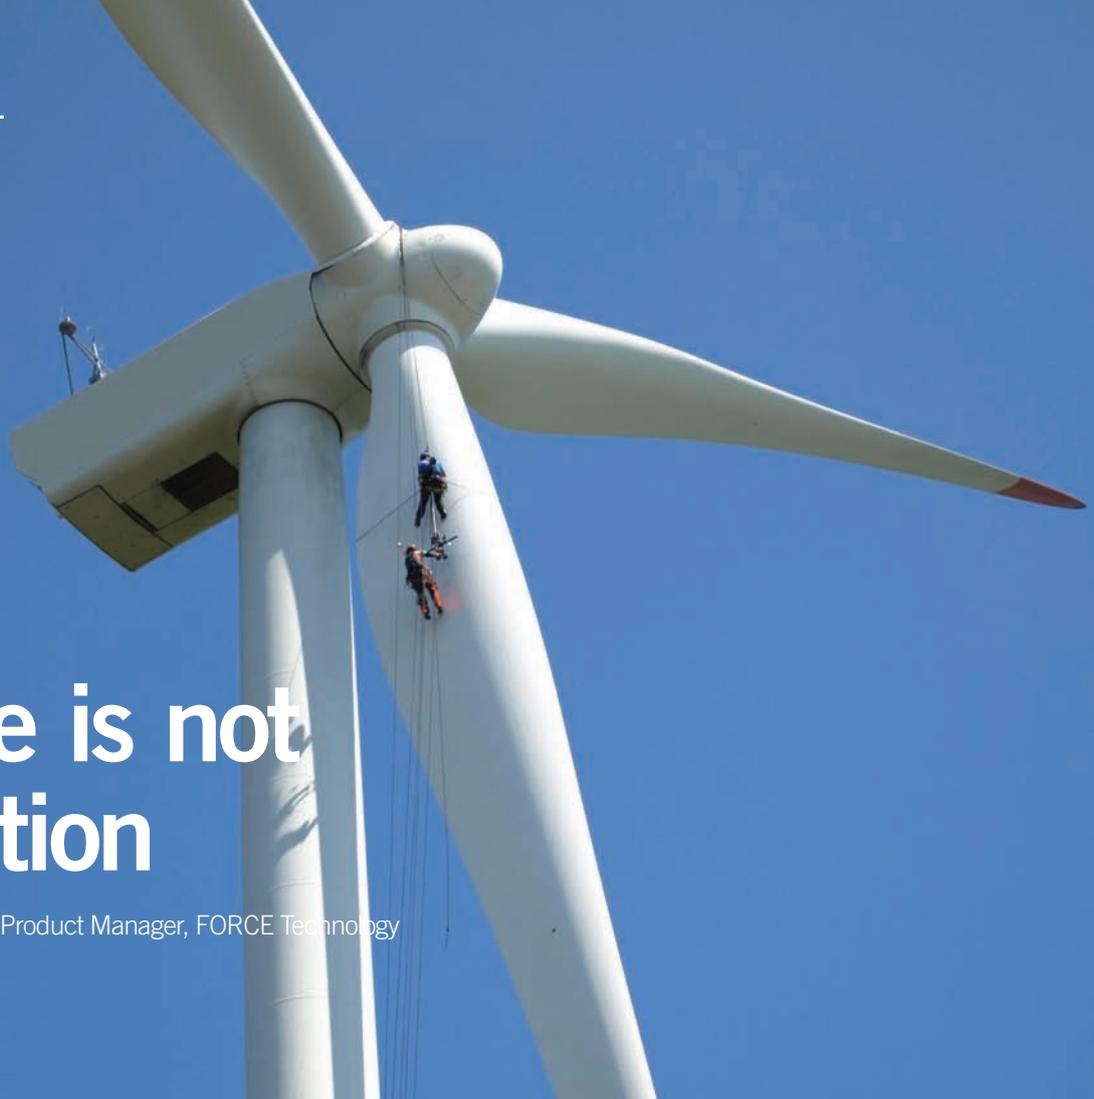
Picture 1: Automated NDT inspection on offshore rotor blades by SPRAT Rope Access.

When there are evidences for serious damages to the blade, decisions for further deeper assessments are needed. To define the extent of hidden cracks and flaws behind a visual indication, a thorough Non-Destructive Testing assessment is prescribed. Automated NDT scanners can be brought up to the blade, operated either

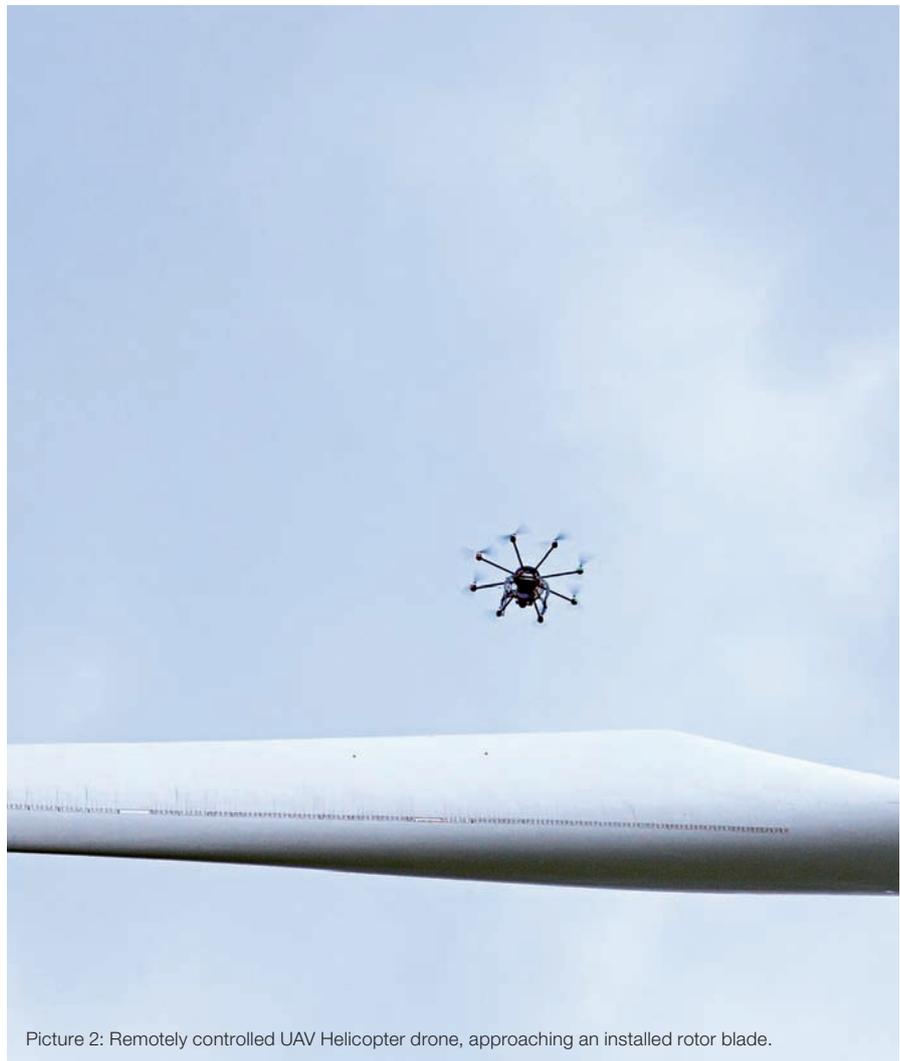
Picture 2: Remotely controlled UAV Helicopter drone, approaching an installed rotor blade.

control program. Cost efficient solutions to execute safe visual surveys are today available, e.g. camera close-up inspection with UAV helicopter drones.

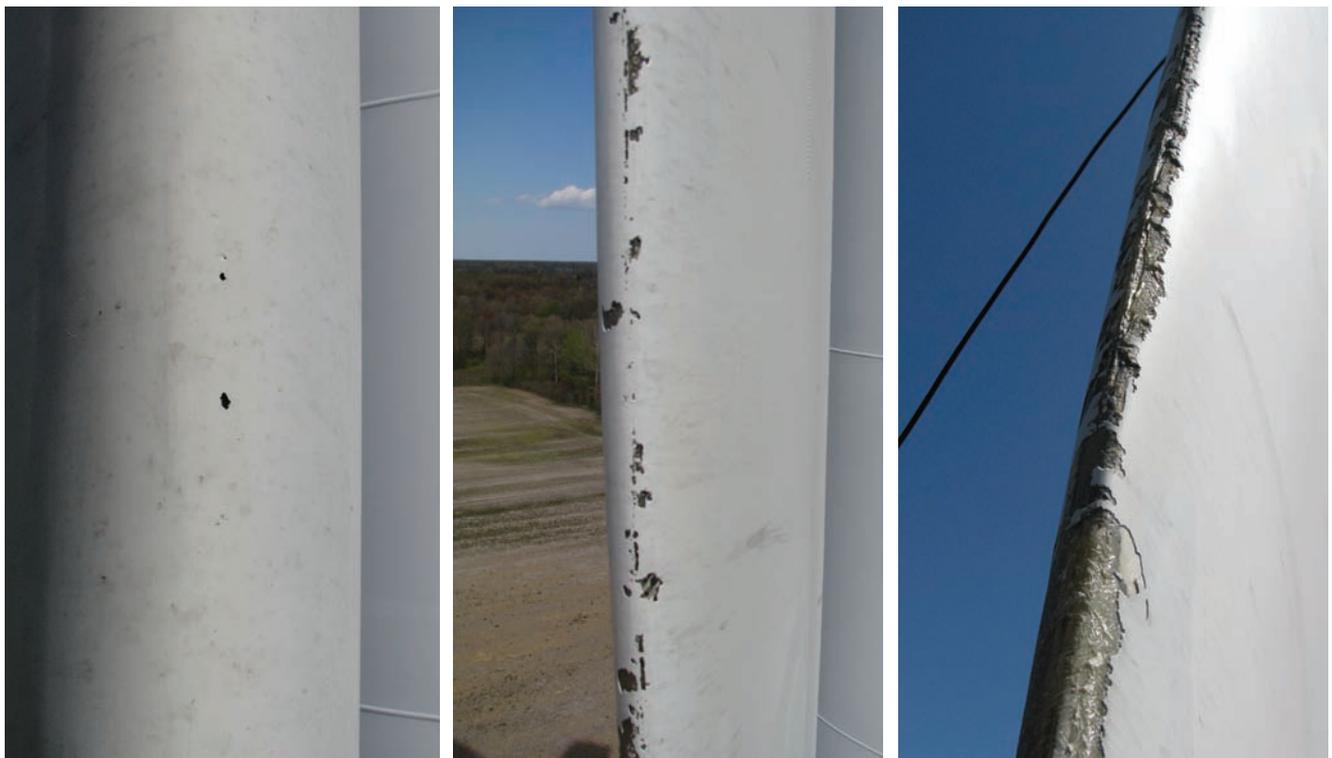
Pictures 3, 4 & 5: Eroded leading edge on installed rotor blades.

Per definition the leading edge is the front edge of the airfoil, the part of the blade that first contacts wind flow. A turbine operate in an air flow containing anything from dust, bugs, sand to rain droplets, sleet, snow and hail, all acting as abrasive air particles. The higher the blade speed, the higher abrasive impact on the blade surface. In normal operation, the blade tip speed is around 100 m/s. The impact of liquid water droplets with rain is quite hard, causing serious erosion damage with time.

Leading edge erosion starts early in the life of a blade. Leading edge protection should be applied as early as possible. If not applied during manufacture, blades as new as three (3) years may show serious signs of wear and tear. The tip of the blade is more susceptible to wear due to the high blade tip speed.
