A revolutionary coating repair system

Humidur anti-corrosion coatings

Application process

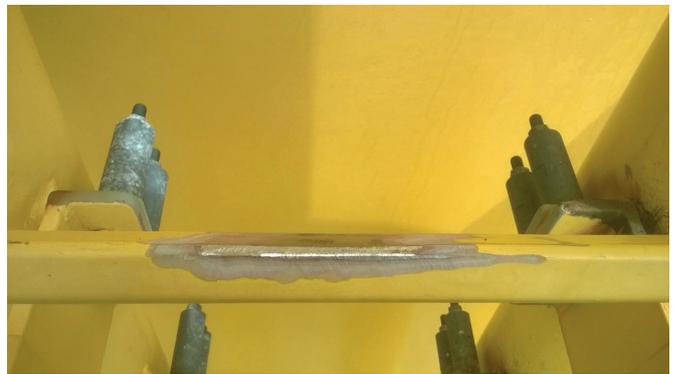
The boat landings are critical areas for the coating system on offshore wind turbines. The coating system is exposed to harsh conditions due to the abrasive action of the boats.

Before a conventional coating was used. Apparently, this coating was applied less than two years before.

As can be seen in the image, the grey coating does not withstand the abrading action exposing the steel to seawater. This shows the importance of selecting the right coating system. The reason of failure could be any of following factors or a combination.

The most straightforward explanation is that the coating does not offer sufficient

abrasion resistance to withstand the forces applied on the boat landings. As the boat landings are in the splash zone/tidal zone and come into contact with water, another plausible cause is that the chosen system is not able to cure correctly due to water or at high humidity. Another factor to take into account is the performance of the coating system on minimally prepared surfaces.

Nevertheless, this coating offers a high quality finish on these boat landings because of its high abrasion resistance and because it can be applied at high humidity. Furthermore, it cures under water disregarding its salinity without sacrificing any of its quality.

The inspection of the boat landings after 2 years proves the superiority of Humidur in these conditions. Visually the coating does not show any degradation.

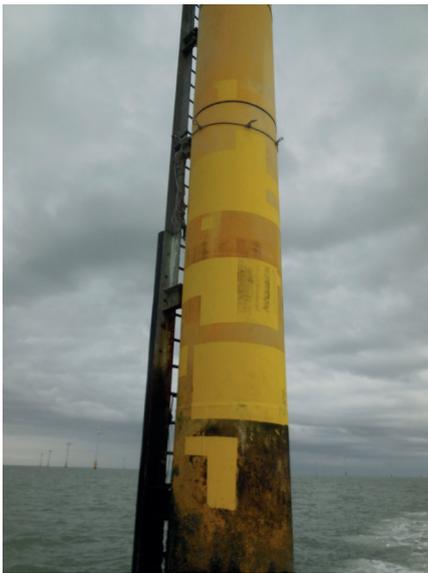
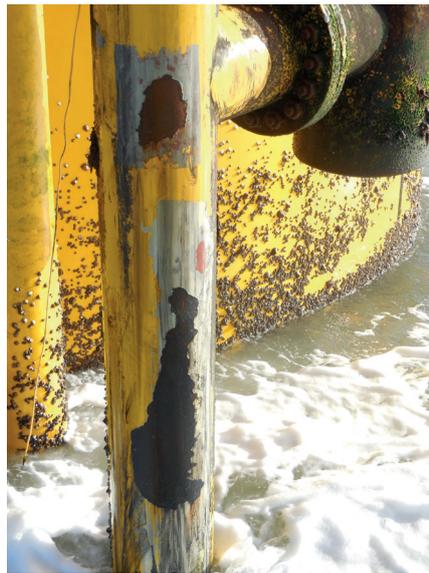
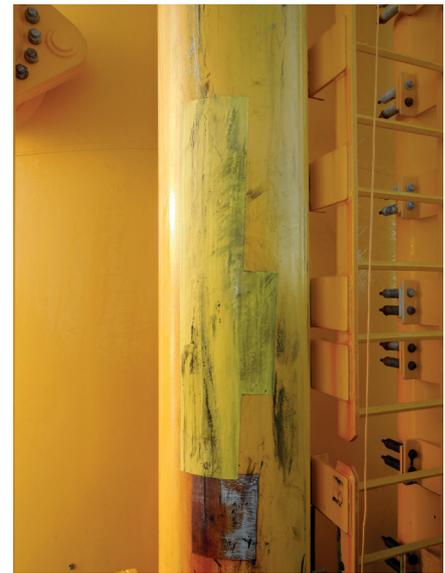
Immediately after surface preparation the coating is applied. The coating is supplied in 1 kg sets. This allows the applicator to proceed easily by rope-access. The sets are simply mixed by pouring pail B into pail A and mixing it. No thinners, which have an adverse effect on the

The coating is applied in one yellow layer, by brush at a thickness of 400 µm. The thickness during application is checked with WFT gauges. As the coating is a solvent-free system, the wet film thickness equals the dry film thickness.
